Tank 16 Annulus Cleaning

Engineering Technology Development

October, 2007

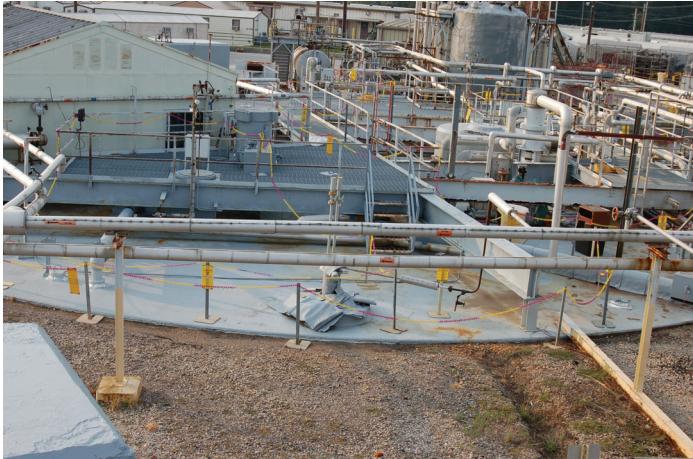
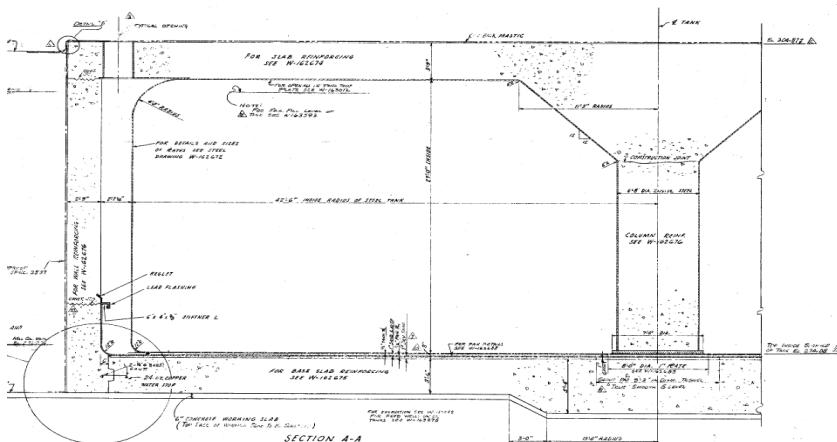
Tank 16 Waste Tank

- **1.1 million gallon capacity**
- **Primary tank with an annulus space**
- **Primary tank is 85' in dia., 27' high with a 3'-9" top slab and is center supported**
- **Annulus space is 2'-6" wide with a ventilation duct at the bottom**
- **Ventilation duct's diameter ranges from 20" down to 12"**
- **Both primary tank & annulus have multiple entry points**

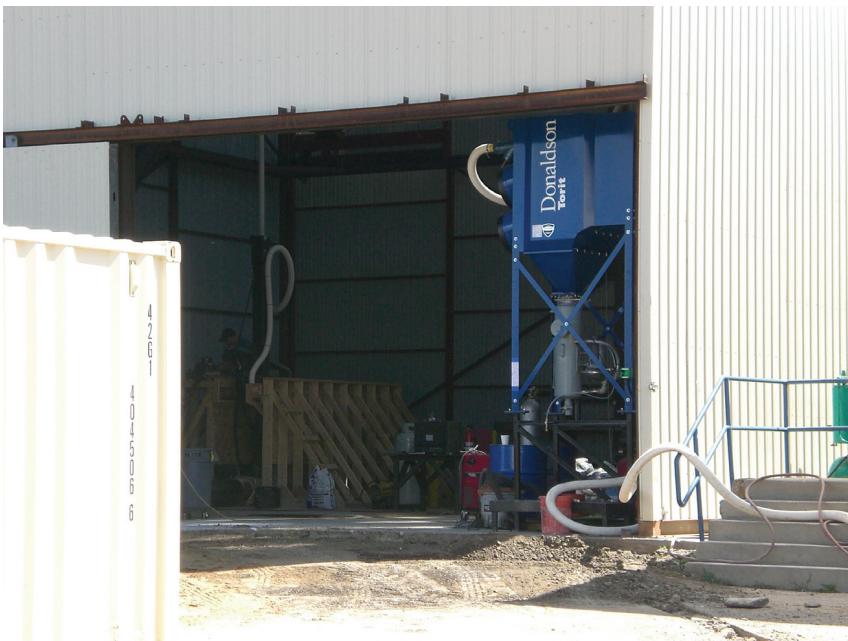
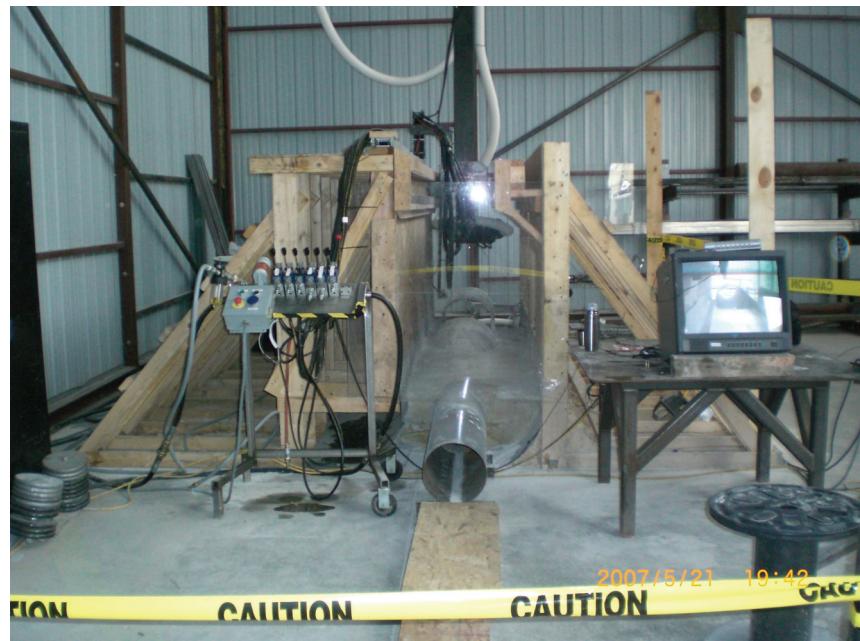
Tank 16 Phase I Demo Facility

- Awarded Phase I contract to SEC on 2/21/07
- Vendor conducted Phase I Demonstration on 5/22-23 at S. A. Robotics in Loveland, CO, with WSRC team present

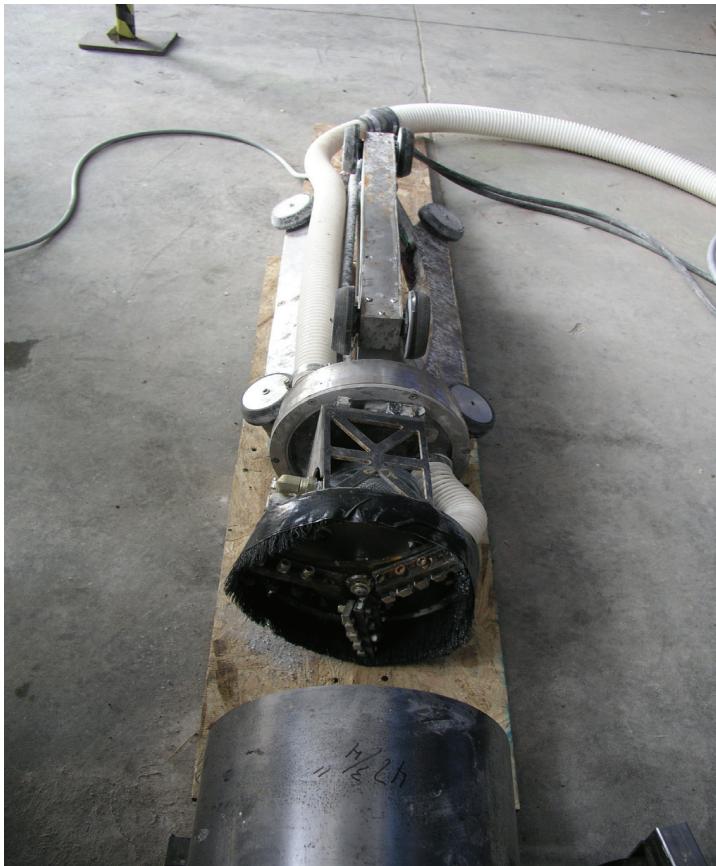
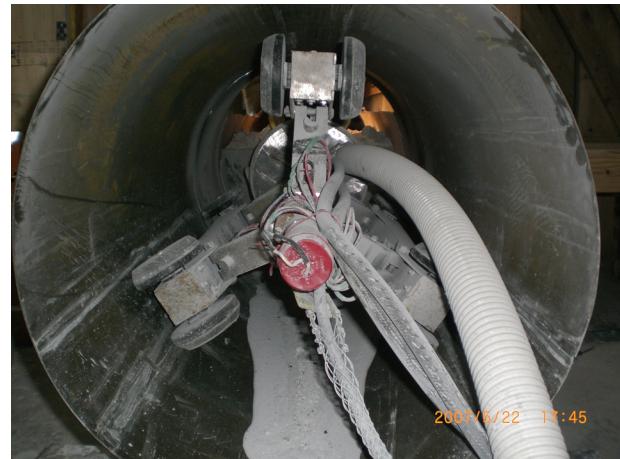
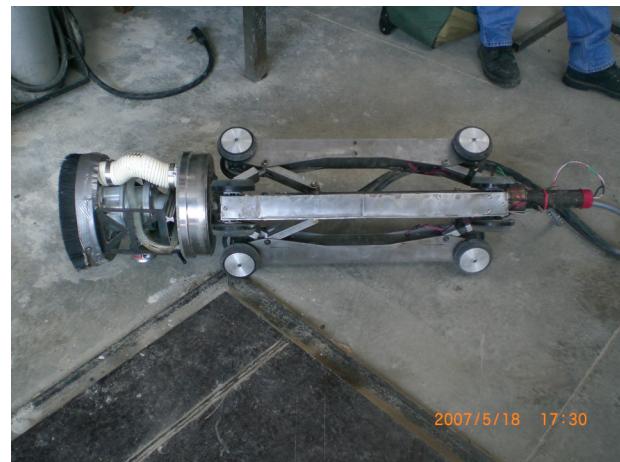
Pipe Crawler with Scarifying Head

Tool	Demonstration	Results
Arm Chipping Hammer Head	To perform waste removal in difficult to access areas.	Successful; dome chipping was performed using 16 point bushing tool. Tool was found to be a great for bulk removal tool.
Pipe Crawler – Scarifying Head	Remove simulant located inside duct	Marginal success with some concerns regarding removal rates. Simplified pipe crawler functioned as designed but wore through unhardened cutting teeth rapidly.
Pipe Crawler – Cutting Head	Size reduce duct	Marginal success, concerns about cutting speed and wear on cutting head.

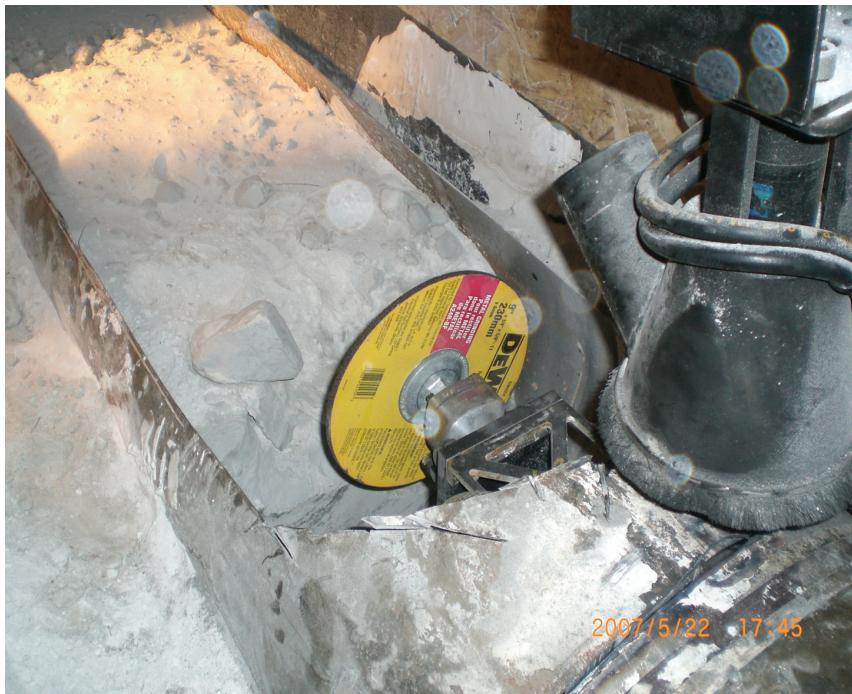
Pipe Crawler with Cutting Head

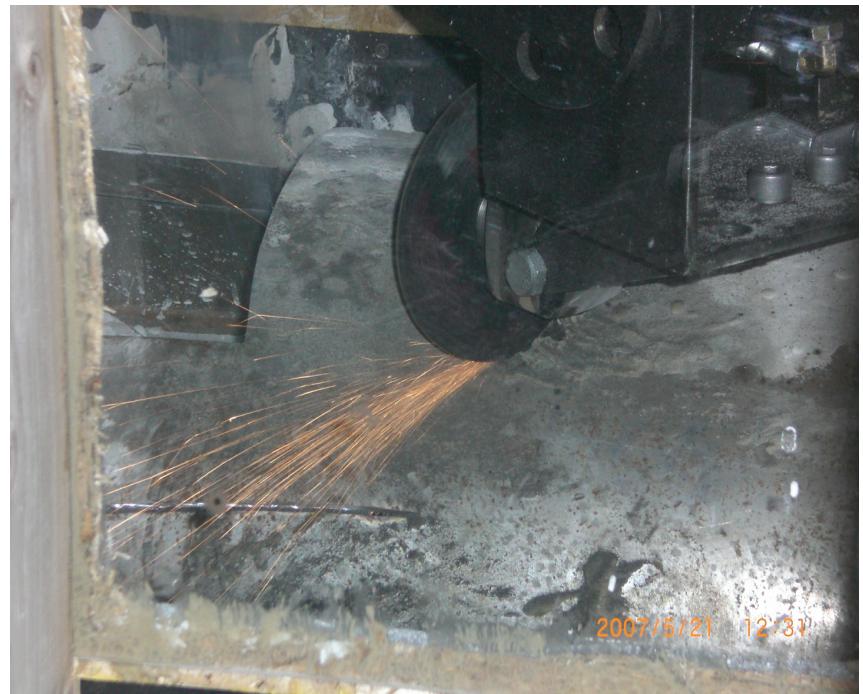
Arm with Cutting Head

Tool	Demonstration	Results
Arm Cutting Head	Cut access opening in 16 gauge duct using remote cutting head	Successful; equip. functioned as designed. Some concern about duct section not detaching completely & sharp edges left behind
Arm Scarifying Head	To remove bulk of simulant from bottom of Tank 16 mockup	Successful; some scarifying was done with initial design but there were major concerns regarding removal rate. Head was modified after the demo and achieved much greater removal rate.
Arm Wire Brush Head	Perform detailed waste removal.	Successful; wire brush performed as designed. No significant dust created.

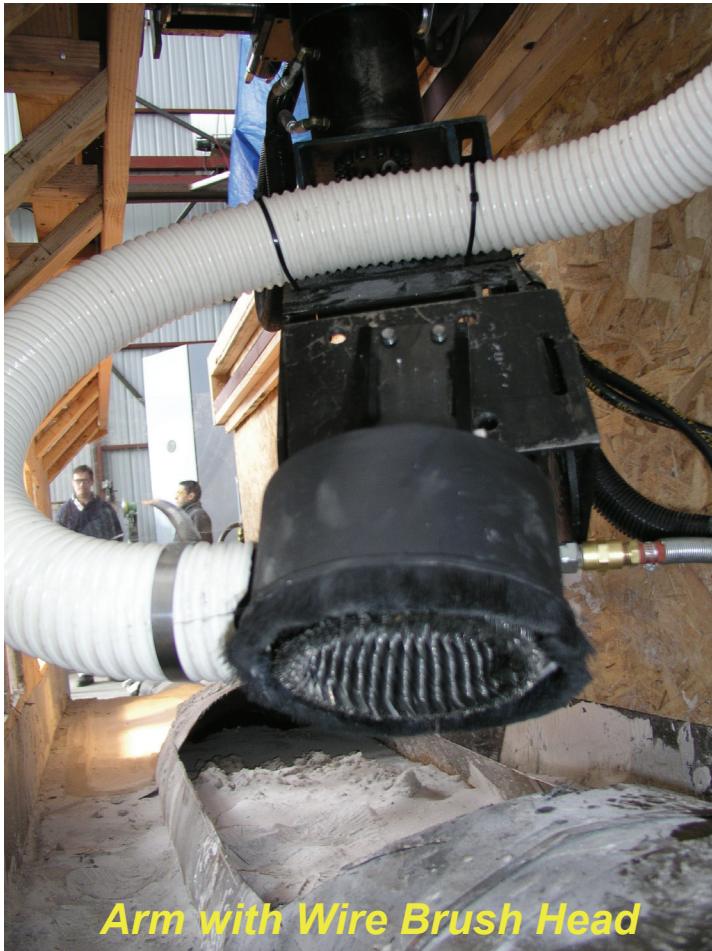
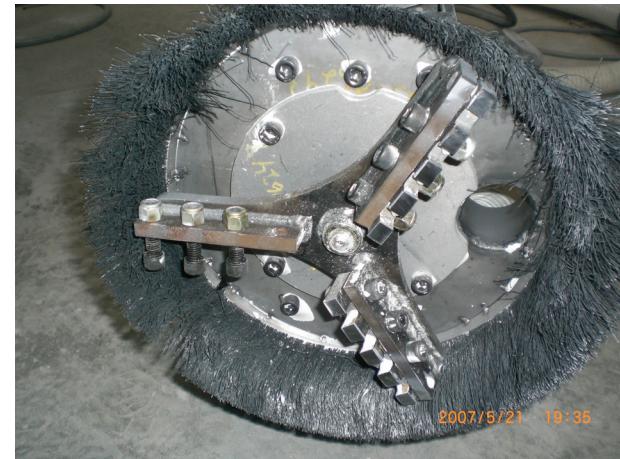
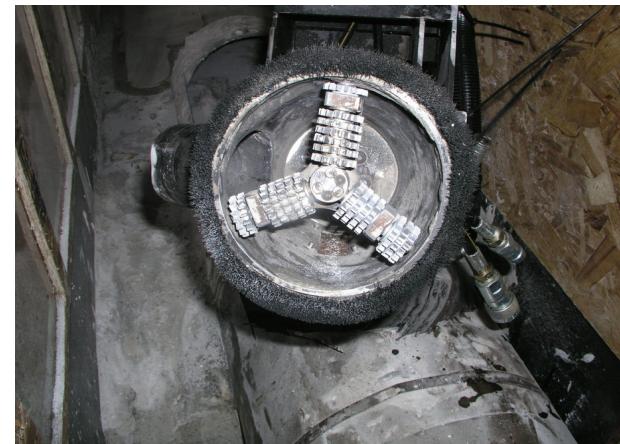
Two Types of Scarifying Heads
